Fatigue Fracture of Bevel Gear of an Aeroengine Gearbox

Technical Report No: MT-FA-1000-05-2006

Subject :	Analysis of failed bevel gear and pinion of engine gearbox PT-6
Submission Date:	May 02, 2006
Issue Date:	May 29, 2006
Customer:	Not disclosed
Reference(s) :	Not disclosed
Total No. of pages:	Twelve (12)
Investigating Team:	M. Suresh Kumar, M. Madan, M.A. Venkataswamy, M. Sujata and S.K. Bhaumik
Approved By:	S.K. Bhaumik
Keywords:	Engine gearbox; bevel gear assembly; weld; residual stresses; fatigue

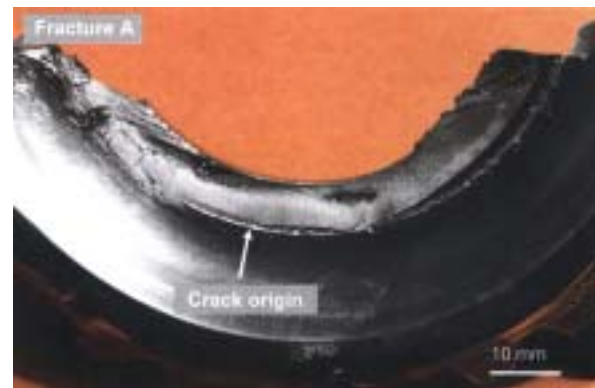
Figure 3. Close-up view of fracture A (refer Fig.2); note the beach marks' orientation.

teethed region. Close-up views of these three regions are shown in Fig.3 to 5. Beach marks, typical of fatigue failure were found present on the fracture surface. Tracing back the beach marks, it was possible to identify the crack origins. For fracture A, the crack was found to have originated at the weld as shown in Fig.2 and 3. For fractures B and C, the cracks appeared to have two origins each, one at the spline root and the other at fracture A (Fig.4 and 5). Observations did not reveal any mechanical abnormalities at the fatigue crack origins.

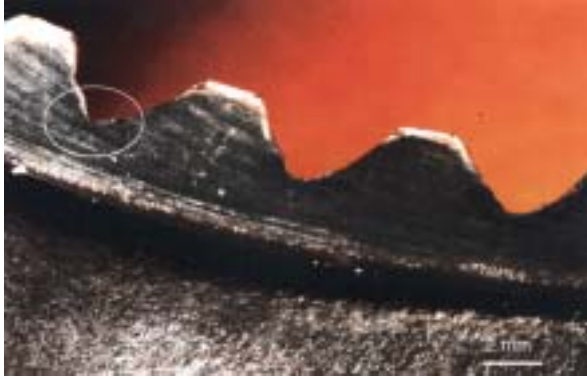
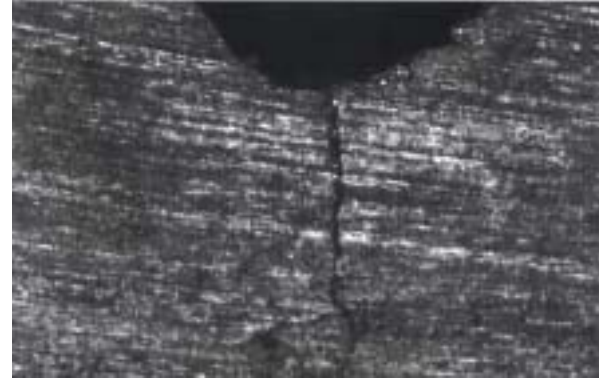
propagating crack from root of a spline can also be seen. Following this observation, the spline roots of the spur gear were examined. All the spline roots were found to have cracks of varying lengths (Fig.8 and 9). Minor deformation and wear were also observed on the splines.

Figure 8. Fatigue cracks at the spline roots.

Figure 9. Magnified view of the crack marked in Fig.8.

The presence of fatigue crack in most of the spline roots of the spur gear needs special attention. It may be recalled that in the earlier failure (ref.1), excessive stresses on the splines of the bevel gear were found to be responsible for the fatigue crack initiation. Also, there were severe deformation and wear on the flank of the spur gear splines. In the post-mod gear assembly, the wear and deformation on the flank of the splines have reduced significantly. This is due to introduction of surface hardening in the splines. But the design modifications carried out in the splines, if any, does not appear to be adequate in reducing the effective stresses on the splines to a significant extent. Fatigue crack initiation in every spline root clearly suggests that the stresses in the post-mod gear assembly are still on the higher side.

- In spite of design modifications, the stresses on the spur gear splines are on the higher side. This needs to be reviewed.

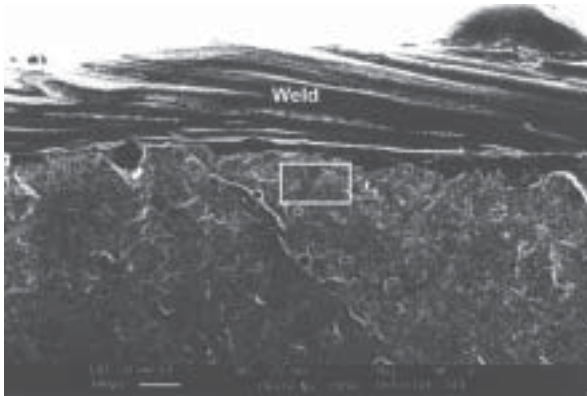
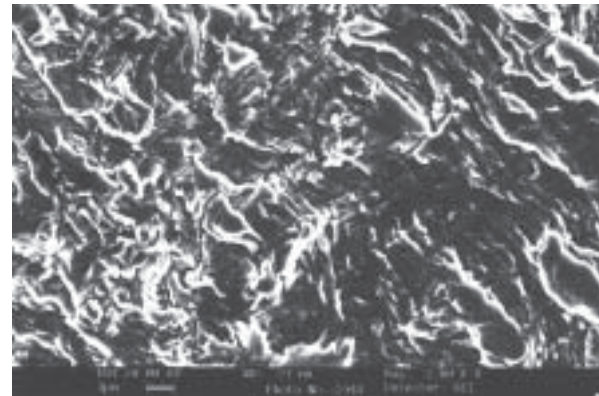
Figure 10. SEM fractograph at the crack origin region on the fracture surface A.

Figure 11. Magnified view of the rectangular region marked in Fig.10 showing fatigue striations.

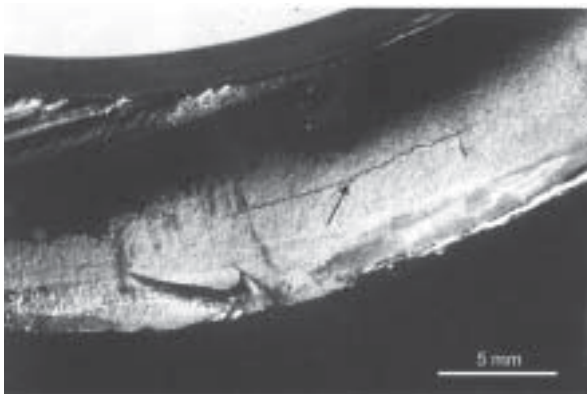
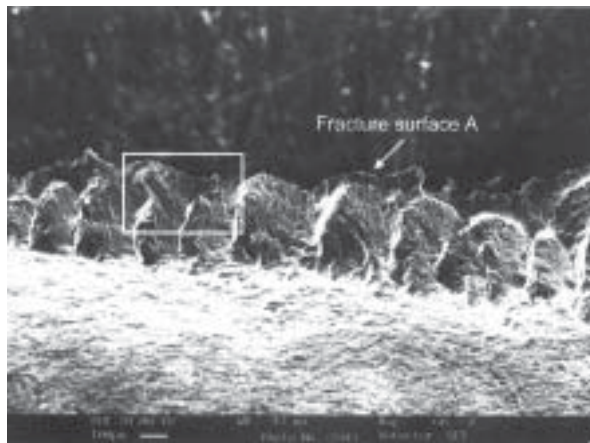
Figure 12. A crack on the fracture surface A (arrow).

Figure 13. Close-up view showing zigzag nature of the crack.

Figure 14. SEM fractograph of the crack shown in Fig. 13.

Figure 15. Magnified view of the rectangular region marked in Fig.14 showing intergranular fracture.

Observation revealed a 15 mm long crack on the fracture surface of the dislodged sector of the gear assembly (Fig.12). But no such crack was observed on the mating fracture surface. The crack was oriented in the circumferential direction and perpendicular to the fracture surface. It was found to follow a zigzag path (Fig.13). Fractographic study showed that the crack was predominantly intergranular in nature (Fig.14 and 15).

The presence of a crack on the fracture surface A (refer Fig.12 and 13) also points towards high residual stresses in the weld. Microstructural study confirmed that this crack had initiated at the weld and propagated in the hub of the spur gear (refer Fig.21 and 22). The intergranular fracture features suggest that the crack has been generated and propagated instantaneously (refer Fig.14 and 15). The confinement of the crack in one of the mating fracture surfaces is noteworthy. This implies that the crack has been generated only after the crack A has passed through and in the process, the residual stresses in the weld have been relieved.

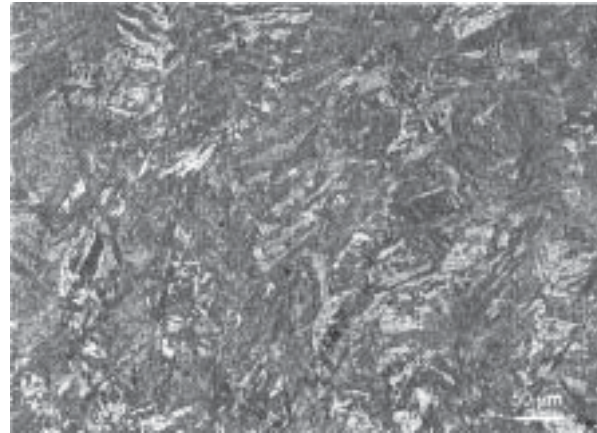
The microstructure across the weld was examined in detail. The microstructure of bevel gear and spur gear material was found to be identical and it consisted of tempered martensitic structure (Fig.17 and 18). On the contrary, an untempered martensitic structure was observed in the weld (Fig.19). The weld structure was very coarse compared to that of the parent material of the gear. The microstructural variation across the weld was found to be significant. The teeth/splines of

Figure 19. Optical microstructure of weld consisting of martensitic structure; etched in 2% Nital solution.

the metallurgical factors appear to have played an important role. The hardness survey across the weld showed unusually low hardness at the weld interface. Also, the hardness of the weld pool is very high compared to that of the parent material (refer Fig.26). This implies that no post weld heat treatment has been carried out. This was also confirmed by microstructural study wherein untempered martensitic structure was observed in the weld (refer Fig.19). The untempered martensitic structure has substantial residual stresses.

- Metallurgical notches/residual stresses are unavoidable while welding hardened materials. In view of this, it is suggested that the gear assembly be fabricated from a single stock.
- If welding is continued, the following is recommended to minimize residual stresses.

The material should be slowly cooled after welding and then tempered immediately, using a temperature slightly lower than the original tempering temperature of the bevel and spur gears.

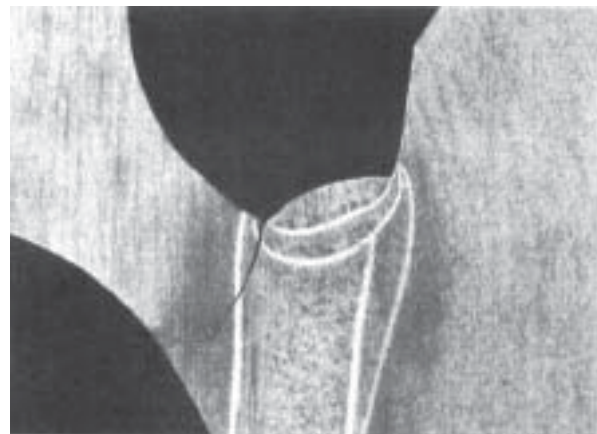
Figure 21. Photograph showing crack at the weld; etched in 2% Nital solution.

Figure 22. Optical microstructure showing crack emanating from the weld; etched in 2% Nital solution.

weld and propagated in the spur gear hub (Fig.21 and 22).
