Fatigue Fracture of Bevel Gear of an Aeroengine Gearbox

Technical Report No: MT-FA-1000-05-2006

Subject :	Analysis of failed bevel gear and pinion of engine gearbox PT-6
Submission Date:	May 02, 2006
Issue Date:	May 29, 2006
Customer:	Not disclosed
Reference(s) :	Not disclosed
Total No. of pages:	Twelve (12)
Investigating Team:	M. Suresh Kumar, M. Madan, M.A. Venkataswamy, M. Sujata and S.K. Bhaumik
Approved By:	S.K. Bhaumik
Keywords:	Engine gearbox; bevel gear assembly; weld; residual stresses; fatigue

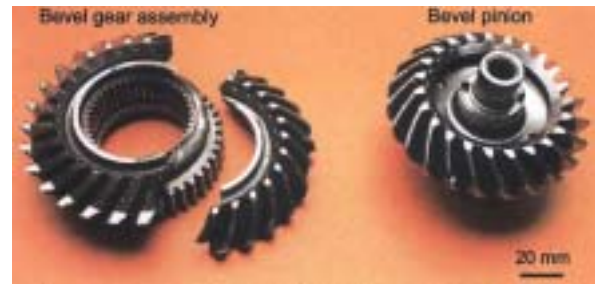
Figure 1. Damaged components of the engine gearbox.

gear assembly was found to have fractured into two pieces. A sector of the bevel gear containing 12 teeth had fractured and fallen off in the gearbox. The fracturing has taken place along the weld. The teeth on this sector were in tact and free from any damages. About 11 teeth on the other part of the gear were almost completely shaved off. The bevel pinion did not have any major damages except for some dent marks caused under impact load. These damages are believed to have occurred after fracture in the bevel gear.

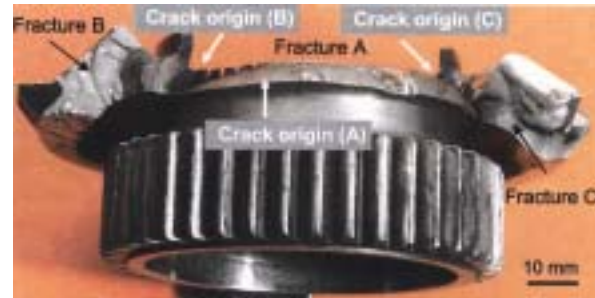
Figure 2. Fracture surface of the bevel gear assembly.

Figure 2 shows the fracture surface of the bevel gear. For ease of explanation, the fracture surface has been divided into three parts and denoted as fracture A, B and C. The fracture A is on the hub of the gear, while fractures B and C are on either side of fracture A and on the

The major crack, which led to the fracturing of bevel gear assembly, has been identified as crack A (refer Fig.2). This crack has initiated at the weld and propagated progressively in the spur gear hub across the thickness as well as in the circumferential direction of the gear assembly (refer Fig.6 and 7). Simultaneously, a number of cracks have initiated at the spline roots of the spur gear and have propagated progressively into the hub (refer Fig.7 to 9). When crack A and the cracks from the spline roots have interacted, new crack fronts such as cracks B and C have been generated and propagated progressively in the flange of the bevel gear leading to the fracturing of a part of the bevel gear (refer Fig.2). This argument is substantiated by the fact that the cracks B

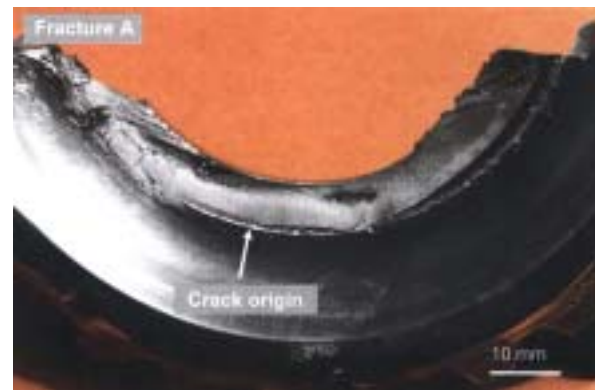
Figure 3. Close-up view of fracture A (refer Fig.2); note the beach marks' orientation.

teethed region. Close-up views of these three regions are shown in Fig.3 to 5. Beach marks, typical of fatigue failure were found present on the fracture surface. Tracing back the beach marks, it was possible to identify the crack origins. For fracture A, the crack was found to have originated at the weld as shown in Fig.2 and 3. For fractures B and C, the cracks appeared to have two origins each, one at the spline root and the other at fracture A (Fig.4 and 5). Observations did not reveal any mechanical abnormalities at the fatigue crack origins.

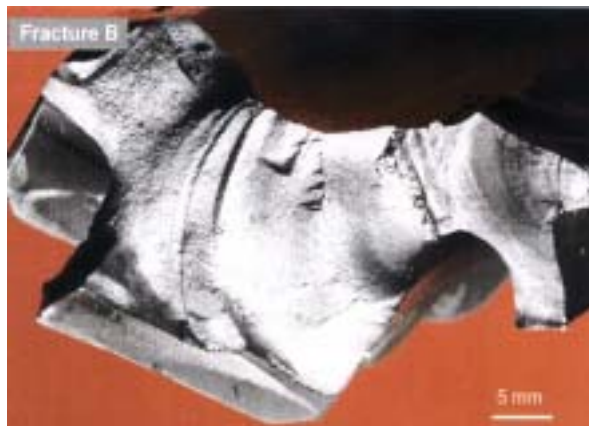
Figure 4. Close-up view of fracture B (refer Fig.2); note the beach marks' orientation.

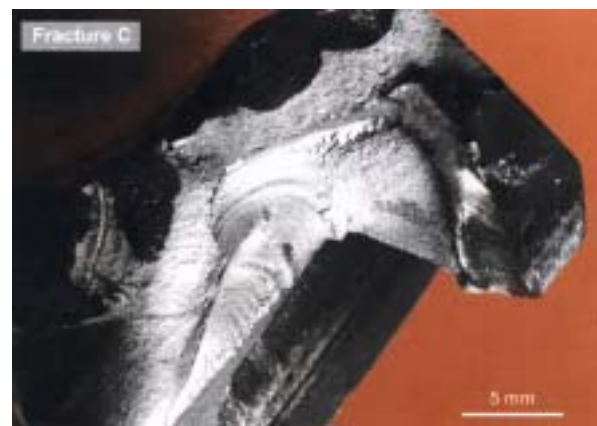
Figure 5. Close-up view of fracture C (refer Fig.2); note the beach marks' orientation.

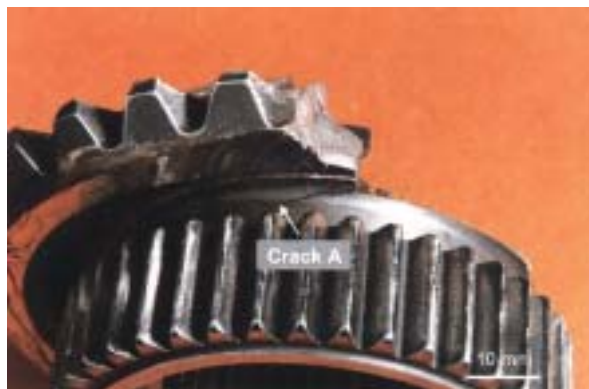
Based on the above observations, the three fracture surfaces A, B and C can now be associated with three independent cracks, viz., cracks A, B and C. The independent nature of these cracks is confirmed through Fig.6 and 7. The progressive propagation of crack A in the hub of spur gear can be seen. Similarly, a

Figure 6. Progressive propagation of crack A in the hub of spur gear.

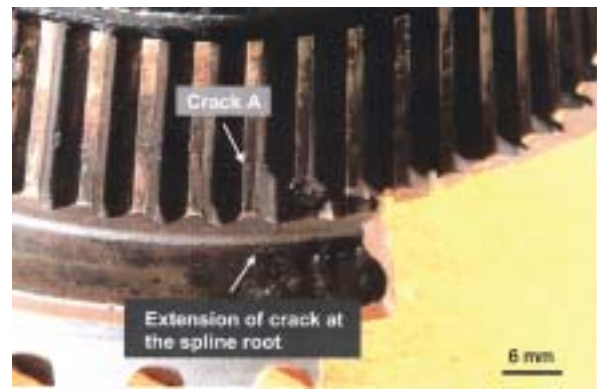
Figure 7. Crack A and extension of a crack at spline root.

propagating crack from root of a spline can also be seen. Following this observation, the spline roots of the spur gear were examined. All the spline roots were found to have cracks of varying lengths (Fig.8 and 9). Minor deformation and wear were also observed on the splines.

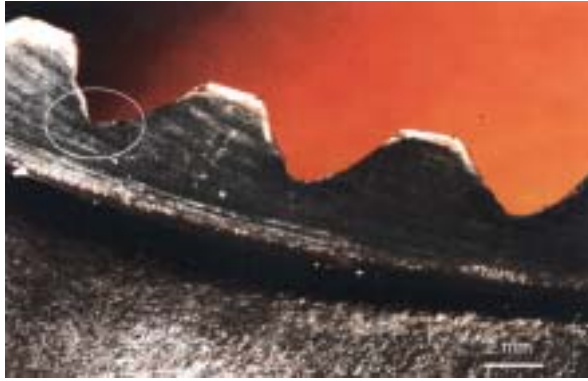
Figure 8. Fatigue cracks at the spline roots.

The presence of fatigue crack in most of the spline roots of the spur gear needs special attention. It may be recalled that in the earlier failure (ref.1), excessive stresses on the splines of the bevel gear were found to be responsible for the fatigue crack initiation. Also, there were severe deformation and wear on the flank of the spur gear splines. In the post-mod gear assembly, the wear and deformation on the flank of the splines have reduced significantly. This is due to introduction of surface hardening in the splines. But the design modifications carried out in the splines, if any, does not appear to be adequate in reducing the effective stresses on the splines to a significant extent. Fatigue crack initiation in every spline root clearly suggests that the stresses in the post-mod gear assembly are still on the higher side.

- In spite of design modifications, the stresses on the spur gear splines are on the higher side. This needs to be reviewed.

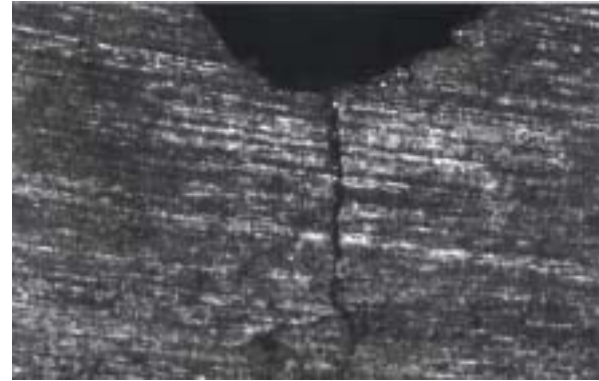
Figure 9. Magnified view of the crack marked in Fig.8.

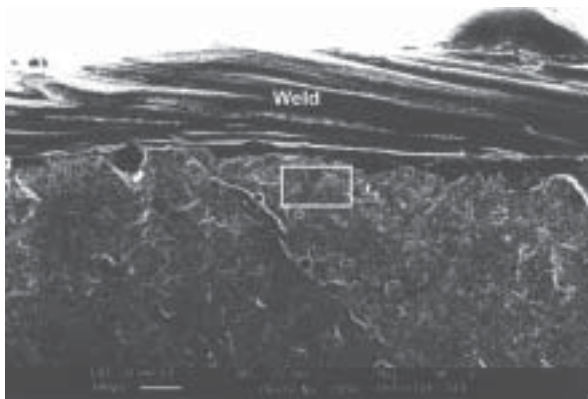
Figure 10. SEM fractograph at the crack origin region on the fracture surface A.

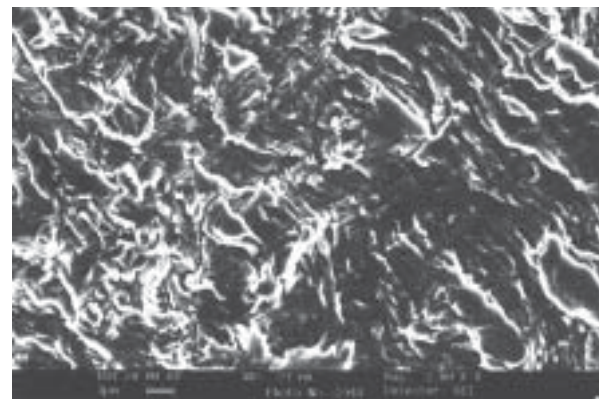
Figure 11. Magnified view of the rectangular region marked in Fig.10 showing fatigue striations.

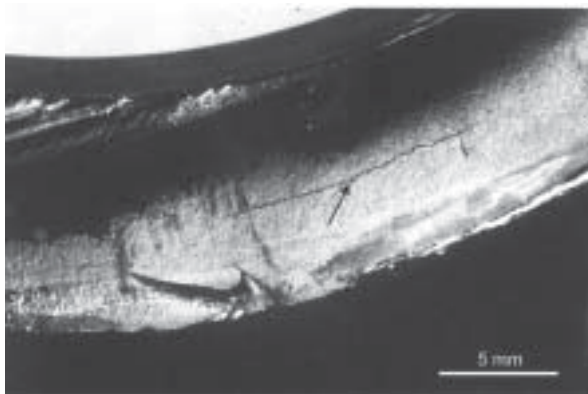
Figure 12. A crack on the fracture surface A (arrow).

Observation revealed a 15 mm long crack on the fracture surface of the dislodged sector of the gear assembly (Fig.12). But no such crack was observed on the mating fracture surface. The crack was oriented in the circumferential direction and perpendicular to the fracture surface. It was found to follow a zigzag path (Fig.13). Fractographic study showed that the crack was predominantly intergranular in nature (Fig.14 and 15).

The presence of a crack on the fracture surface A (refer Fig.12 and 13) also points towards high residual stresses in the weld. Microstructural study confirmed that this crack had initiated at the weld and propagated in the hub of the spur gear (refer Fig.21 and 22). The intergranular fracture features suggest that the crack has been generated and propagated instantaneously (refer Fig.14 and 15). The confinement of the crack in one of the mating fracture surfaces is noteworthy. This implies that the crack has been generated only after the crack A has passed through and in the process, the residual stresses in the weld have been relieved.

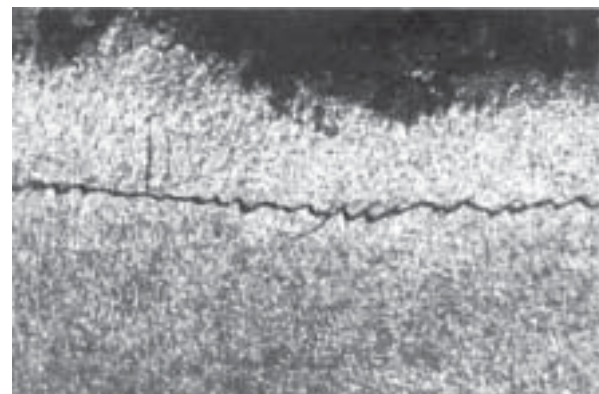
Figure 13. Close-up view showing zigzag nature of the crack.

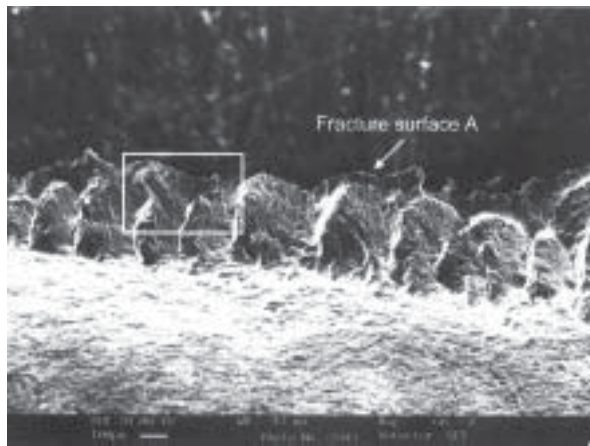
Figure 14. SEM fractograph of the crack shown in Fig. 13.

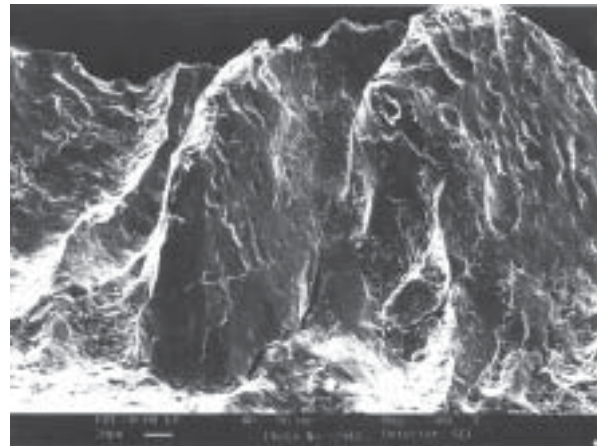
Figure 15. Magnified view of the rectangular region marked in Fig. 14 showing intergranular fracture.

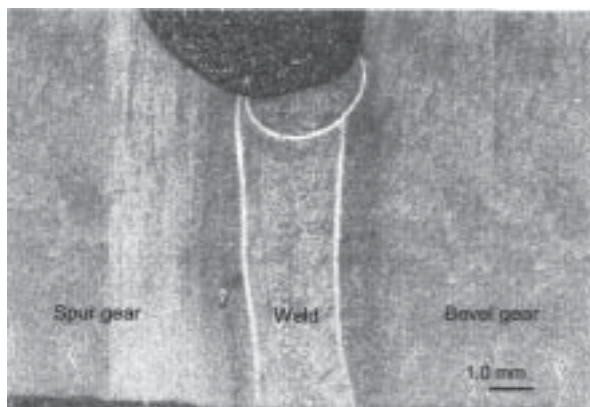
Figure 16. Optical micrograph showing the weld profile; etched in 2% Nital solution.

optical microscope. Figure 16 shows the weld profile. The weld pool had a width of about 2 mm. The weld did not have any defects like voids or porosity. The weld – parent metal interfaces were clearly distinguishable from the weld as well as parent metal (Fig.16).

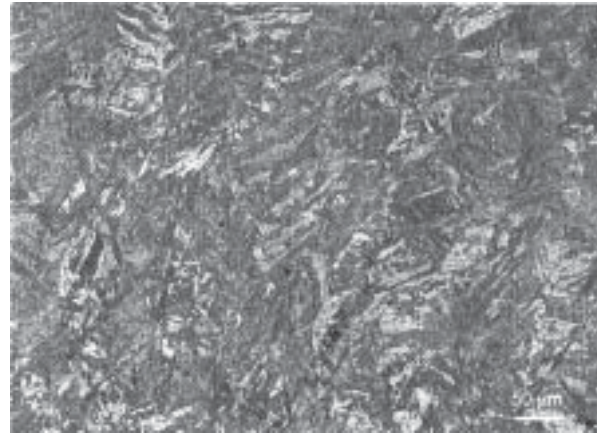
The microstructure across the weld was examined in detail. The microstructure of bevel gear and spur gear material was found to be identical and it consisted of tempered martensitic structure (Fig.17 and 18). On the contrary, an untempered martensitic structure was observed in the weld (Fig.19). The weld structure was very coarse compared to that of the parent material of the gear. The microstructural variation across the weld was found to be significant. The teeth/splines of

Figure 19. Optical microstructure of weld consisting of martensitic structure; etched in 2% Nital solution.

the metallurgical factors appear to have played an important role. The hardness survey across the weld showed unusually low hardness at the weld interface. Also, the hardness of the weld pool is very high compared to that of the parent material (refer Fig.26). This implies that no post weld heat treatment has been carried out. This was also confirmed by microstructural study wherein untempered martensitic structure was observed in the weld (refer Fig.19). The untempered martensitic structure has substantial residual stresses.

- Metallurgical notches/residual stresses are unavoidable while welding hardened materials. In view of this, it is suggested that the gear assembly be fabricated from a single stock.
- If welding is continued, the following is recommended to minimize residual stresses.

The material should be slowly cooled after welding and then tempered immediately, using a temperature slightly lower than the original tempering temperature of the bevel and spur gears.

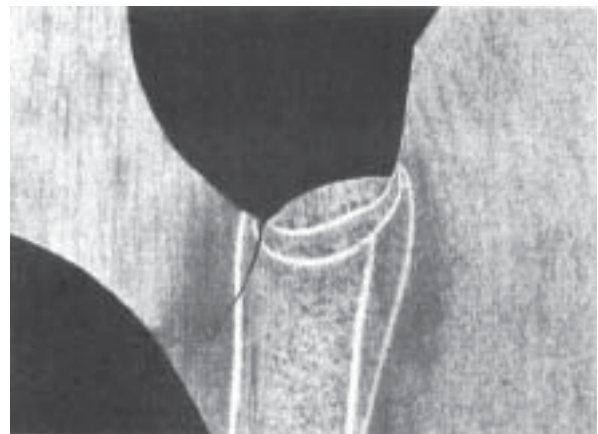
Figure 21. Photograph showing crack at the weld; etched in 2% Nital solution.

weld and propagated in the spur gear hub (Fig.21 and 22).

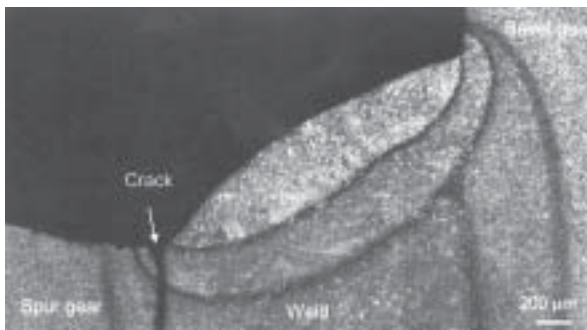
Figure 22. Optical microstructure showing crack emanating from the weld; etched in 2% Nital solution.

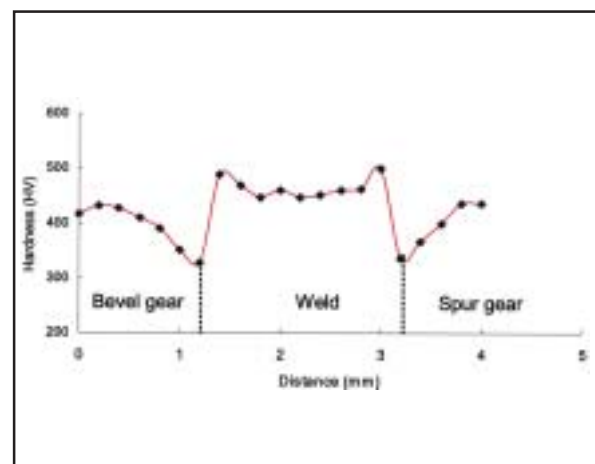
weld was quite significant (Fig.26). The hardness of the weld was as high as 500 HV (49 R_c) while that at the weld interface was as low as 328 HV (33 R_c).

Figure 26. Hardness distribution across the weld.
