CSIR-NML's EXPERTISE ON LIFE ESTIMATION AND DAMAGE EVALUATION OF AIRCRAFTS

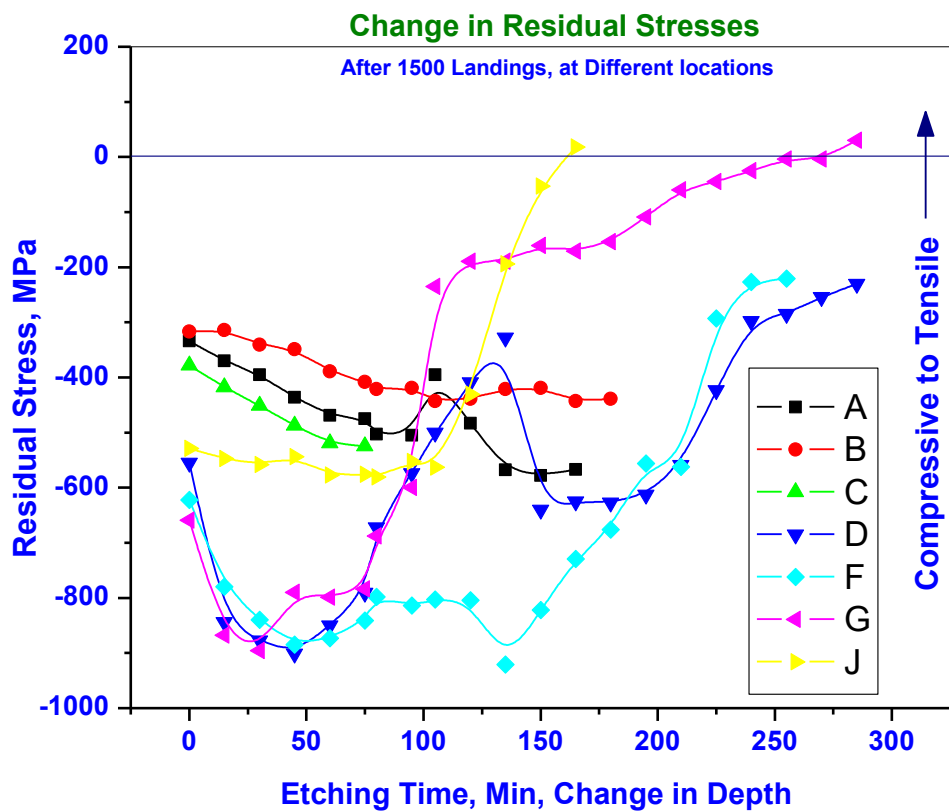
Compressive stress field (CRSF) study by layer removal technique was found to be varied from location to location of life-expired MLG. The profile at location 4 has shown a decreasing trend, location 5 has nearly flat nature and the profile at location 6 was of initial increasing nature and then decreasing. Moreover, the depths of CRSF (Z0) as well as compressive residual stress at the surface (σ_{src}) at various locations are in following order: location 4 > location 5 > location 6. The residual stress at the investigated subsurface region remained compressive at location 4 while it changed to tensile at locations 5 & 6. Typical variation in residual profile after 1500 landings is shown in figure

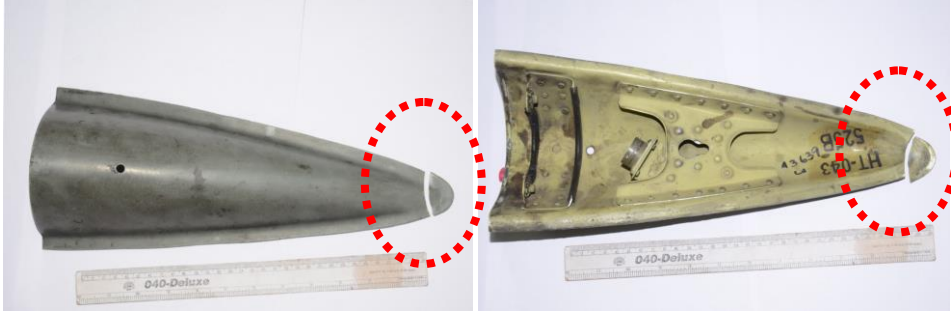
<p>Red dotted circle shows broken region</p>
Scope	<ol style="list-style-type: none"> 1) Visual examination, photographic recording and sampling of the damaged portion of the fairing assembly. 2) Chemical analysis. 3) Microstructural analysis and hardness measurement. 4) Fractography & surface analysis by SEM-EDS. 5) Identification of foreign object if any.
Finding	<p>Failure investigation of the broken fairing of aileron PCU-LH of Hawk MK132 A-3653 aircraft was carried out through visual examination, chemical analysis, microstructure analysis and fractography by SEM-EDS. Visual observation showed that the fairing was broken into two halves approximately at 20 mm from the tip. The broken piece was around 20mm X 35mm X 1.4mm in size. Visual examination and SEM-EDS analysis revealed several line marks near the fractured region due to cracking of the coating on the outer surface of the broken fairing tip. The cracks on the coating occurred due to the deformation of the base metal underneath the coating. Deformation of the base metal occurred because of stress concentration around the region. However, evidence of FOD was not found on the outer surface of the broken tip and rest part of the fairing. Visual examination of the inner surface of the broken fairing tip showed damage/removal of the coating at the tip region. Beside damage of the coating at the tip, no other damage was observed in rest portion of the fairing. SEM-EDS analysis of the damaged coating showed that the inner coating was removed by the repeated knocking of</p>

the tip against the surface of the wing. Chemical analysis of the fairing material showed that it was made of Al-Cu alloy of 2014 grade. Microstructure analysis and hardness measurement also conformed to the aluminium alloy of grade 2014. Fractography of the fractured surface revealed the signatures of progressive mode of failure. Hence it was concluded that the fairing was broken due to fatigue failure and not due to shearing/overload failure. Hence failure due to impact of an object was ruled out. SEM-EDS analysis showed that fatigue crack initiation and propagation was from the inner surface of the fairing. Fatigue failure occurred because of repeated knocking of the tip against the wing. Repeated knocking action might have been due to the existence of slight relative movement and aerodynamic condition prevailing on the fairing during service operation.

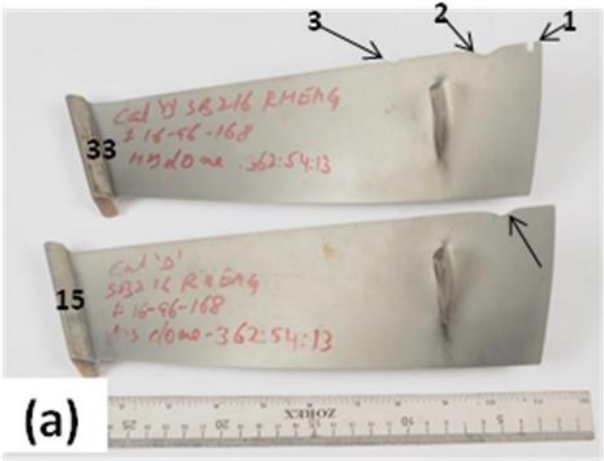
at 84.5 mm from the tip of the blade along the leading edge. Dent 1 was approximately 4 mm wide and 5.5 mm deep, Dent 2 was approximately 20.5 mm wide and 3.5 mm deep and Dent 3 was approximately 8.5 mm wide and 1 mm deep. Chemical analysis confirmed that the blades were made of titanium based alloy of type (Ti-6Al-4V). Microstructure analysis did not show any abnormality in the microstructure of the blades. Microstructure of the blades was consisting of alpha (α) and alpha + beta ($\alpha+\beta$) structure of Ti-6Al-4V alloy. Fractography/damaged surface analysis by SEM-EDS confirmed that blades were damaged due to impacts of an iron based metallic object.

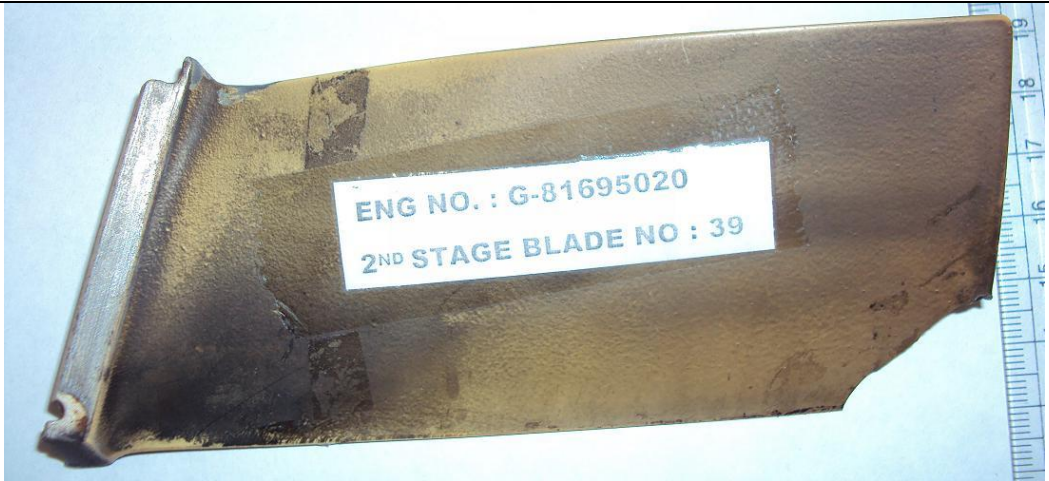
Scope	<ol style="list-style-type: none"> 1. Visual examination and photographs recording 2. SEM Fractographic study to find out the failure mode/mechanism. 3. Surface studies to find out nature and mechanism of surface degradation/damages. 4. Microstructure investigation and EDS microanalysis. 5. Hardness measurement.
Finding	<p>Failure investigation of a damaged second stage compressor rotor blade of R-13 aero engine was carried out. No microstructural/material defect was observed. The blade is made of martensitic stainless steel of Russian grade AE 961W and has protective coating. The hardness value of the blade is within specified limit. The pressure surface of the blade has undergone erosion in the form of cracks, pits/craters by impact of sand particles. Protective coating was completely eroded along the leading edge near tip region due to abrasion of sand particles. The failure of the blade was due to fatigue initiated from the pits/craters formed on the bare base metal due to impact of sand particles. Fatigue crack was propagated from surface crack/crater due to complex cyclic loading condition of engine off and on; coupled with vibration characteristics during flight.</p> <p>In order to mitigate the problem, frequent inspection of blades for coating damages should be carried out. Secondly, feasibility of recoating of blades along leading edges as coating gets damaged may be explored.</p>

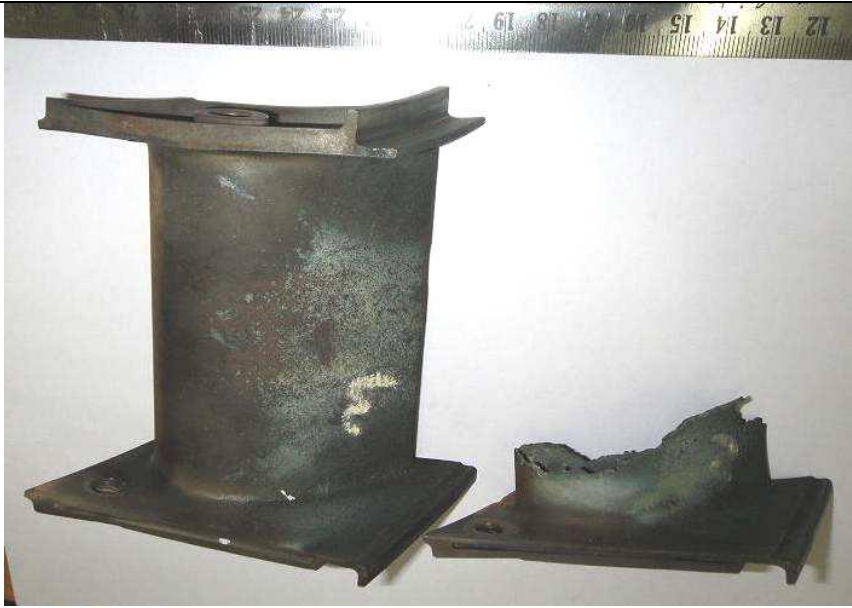
Scope	<ul style="list-style-type: none"> ➤ Visual examination and photographs recording. ➤ Chemical analysis. ➤ SEM Fractographic study to find out the failure mode/mechanism. ➤ Microstructure investigation/analysis and Hardness measurement. ➤ Microstructure analysis and Coating analysis of the undamaged NGV by Optical Microscopy and Scanning Electron Microscopy (SEM).
Finding	<p>Failure investigation of a damaged 1st stage nozzle guide vane (NGV) of R-25 aero engine was carried out to determine cause of failure, coating condition and material degradation due to high temperature in comparison to an undamaged nozzle guide vane obtained from the same stage. Chemical analysis of both NGV's conforms to nickel based super alloy of Russian grade ZC6Y-BE. Microstructure analysis showed that both NGV's consist of gamma and gamma prime (γ-γ') matrix having cast dendritic morphology along with coarser primary carbides. Discontinuities/cavities at inter-dendritic region were also observed in both the NGV's. However the microstructural degradation is more predominant at the damaged location of the damaged NGV's. It is interesting to note that at the same location for the undamaged NGV also showed similar microstructural degradation.</p> <p>Coating analysis revealed degradation / depletion of coating at the</p>

leading edge of the undamaged NGV. However at the trailing edge (suction side) the coating thickness was heavy appears to be second coating. In case of failed NGV, the coating was damaged/depleted up to ~5 mm from the damaged portion towards the shrouded end.

Failure of the 1st stage nozzle guide vane (NGV) was due to high temperature oxidation assisted by creep and thermal fatigue. Degradation /damage of coating might have assisted the high temperature oxidation to occur. Rise in temperature accelerated the precipitation and coarsening of chromium rich secondary carbides rendering the oxidation of Ni base matrix especially around chromium rich precipitates. Inter dendritic cavities/discontinuities were generated because of high temperature creep and thermal fatigue. These cavities/discontinuities provided the easy diffusion paths for oxygen transport enhancing high temperature oxidation of the nickel matrix.

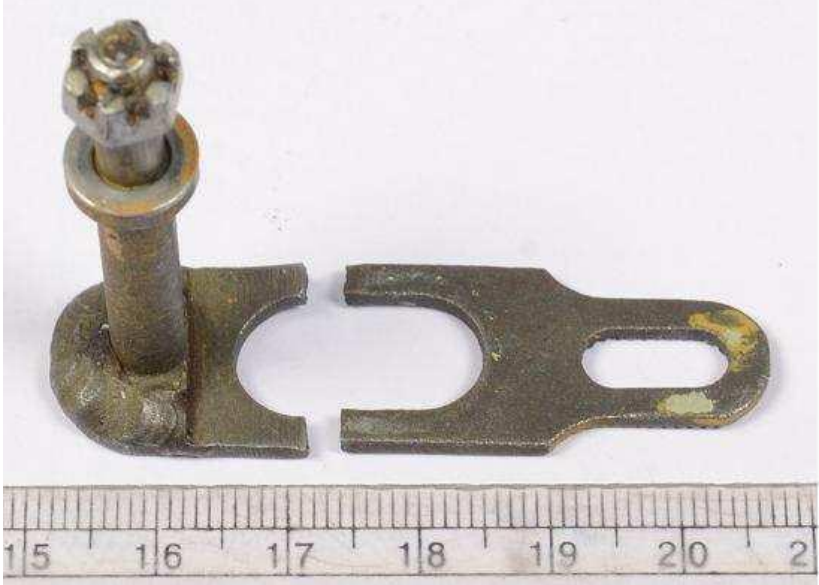
Scope	<ul style="list-style-type: none"> ➤ Visual examination and photographic recording. ➤ Chemical analysis ➤ SEM fractography and surface study to find out the failure mode/mechanism. ➤ Metallographic study and hardness measurements to find out any unusual microstructural features, if any. ➤ To find out the causes and circumstances of failure and suggest remedial measures
Finding	<p>Failure investigation of the broken mounting bracket (Pt. No-75-5102-92) of DASU-1A of Mig-21 (Bison) aircraft CU-2316 was carried out through visual examination, chemical analysis, microstructure analysis and fractography by SEM-EDS. The mounting bracket was broken into two pieces from the centre hole. It was ruptured along the transverse section at two locations along the diagonal of the centre hole creating four fractured surfaces (i.e. two mating fracture surfaces from one location). Fractured surface from one location is marked A and the other fractured surface from the diagonally opposite location is marked B for convenience. During visual examination, significant corrosion/oxide</p>

formation observed on the fractured surface B, compared to the fractured surface A. Significant corrosion/oxide formation on the fracture surface may be inferred that it is a time dependent failure and not a sudden failure. Microstructure consists of tempered martensite with slightly higher amount of inclusions. Tempered martensite is common in quenched and tempered low alloy steel. Fractographic studies by SEM-EDS revealed regular steps marks due to crack propagation by cyclic load and elongated radial cracks around the neutral axis (central region) due to the detachment of interfaces between the matrix and inclusions, hence it may be inferred that that the bracket was failed due to reverse bending fatigue. Fatigue was initiated from the inclusions situated on surfaces/subsurface of the bracket under the reverse bending load and propagated for some time before fracture. Moreover, corrosion product/oxides on the fatigue cracked surface were also noticed indicating time dependent fatigue failure. The reverse bending fatigue condition might have arisen due to improper fastening /loose of the mounting bracket coupled with vibration of the aircraft. Moreover, martensitic steels are low fracture toughness materials and aggravated by the presence of inclusions, hence could not with stand the fatigue load.

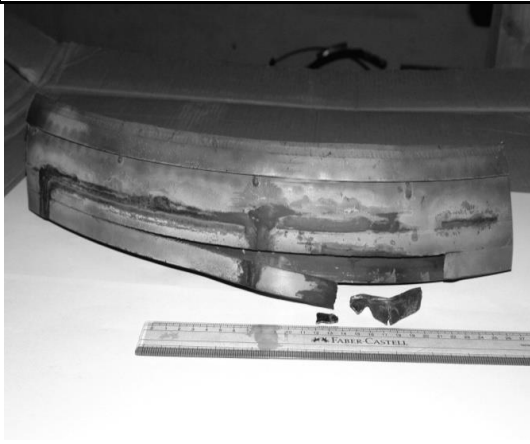
<p><i>Damaged rear flange flame tube</i></p>
Scope	<p>In Kalaikunda during Aug'2010, at the time of crank of engine de-inhibition run on MIG-27 ML TS-615 aircraft, abnormal rattling sound was heard from jet nozzle area after completion of TS cycle. Post flight inspection of the aircraft revealed adherence of non-magnetic metal particle on LPTR blade at 7 o'clock position, small fragment within the jet nozzle and dent at 3 and 4 o'clock positions over second stage nozzle guide vanes. To explore the root cause of this incident, the scope has been illustrated as</p> <ol style="list-style-type: none"> 4. Microstructural examination near damaged, un-damaged and weld location. 5. Fractographic investigation. 6. Mechanical properties evaluation close to the damage. 	
Finding

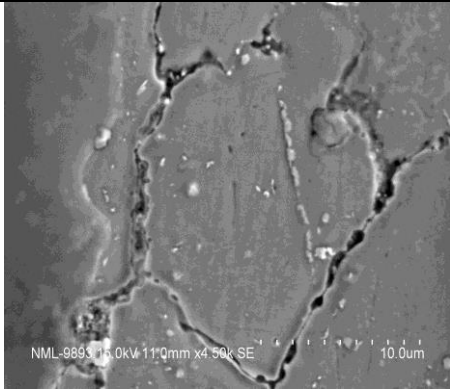
<p><i>Cavitation in surface section</i></p>

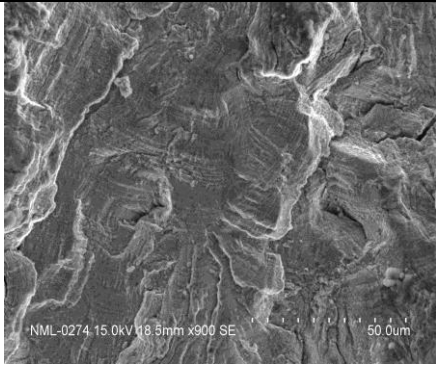
<p><i>Fatigue striation at one end of fragmentation</i></p> </div> <div data-bbox="355 607 793 972">

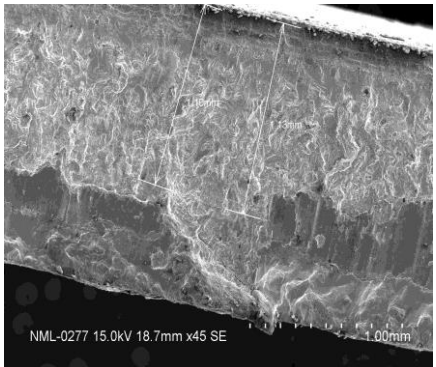
<p><i>Overall display of regions covered with fatigue striations</i></p> </div>
<p>Inferences</p>	<ol style="list-style-type: none"> 1. The component is made of Ni base solid solution single phase of AE 868, decorated with alloy carbide. At few locations grain boundary de-cohesion was found which may be the manifestation of high temperature exposure. 2. For rear flange flame tube the fatigue crack was found to be initiated near the weld region. Cyclic thermal stress developed within the component owing to the change in temperature from ambient to several hundred degrees. Thermal fatigue is thus a damage mechanism, enhanced by the generated stress during thermal cycling within the component. The phenomenon was manifested by fatigue crack growth and lead to circumferential separation along the weld. 3. The failure of the other parts of the component was secondary in nature and owing to fast fracture. The weld joint failure lead to imbalance in load distribution through the other part of the component; hence the other failed locations exhibited characteristic feature of dimple fracture due to overload under hoop stress.
