Fatigue Fracture of Bevel Gear of an Aeroengine Gearbox

Technical Report No: MT-FA-1000-05-2006

Subject :	Analysis of failed bevel gear and pinion of engine gearbox PT-6
Submission Date:	May 02, 2006
Issue Date:	May 29, 2006
Customer:	Not disclosed
Reference(s) :	Not disclosed
Total No. of pages:	Twelve (12)
Investigating Team:	M. Suresh Kumar, M. Madan, M.A. Venkataswamy, M. Sujata and S.K. Bhaumik
Approved By:	S.K. Bhaumik
Keywords:	Engine gearbox; bevel gear assembly; weld; residual stresses; fatigue

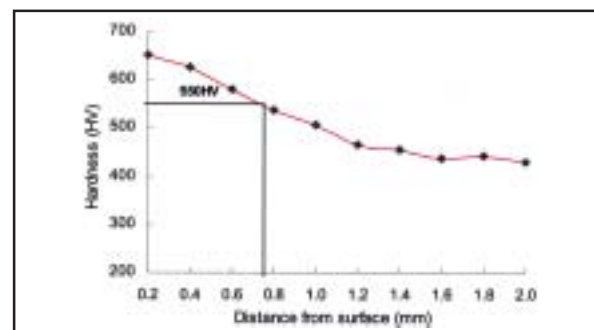
Figure 23. Hardness distribution across the bevel gear tooth thickness.

Hardness survey was carried out on metallographically prepared samples using a microhardness tester at a load of 500 g. The hardness profiles on the gear teeth/splines and across the weld are shown in Fig. 23 to 26. The results obtained are summarized in Table 2.

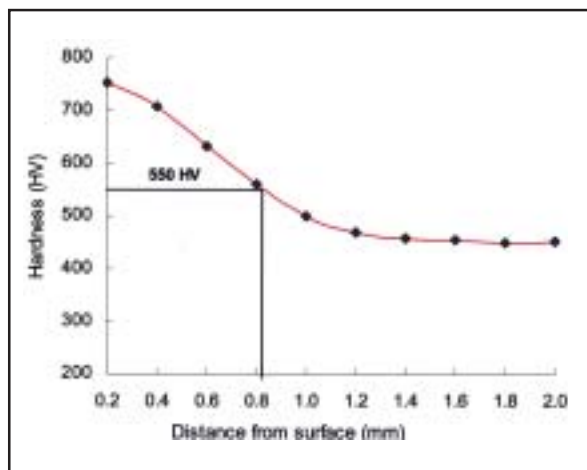
Figure 24. Hardness distribution across the spur gear tooth thickness.

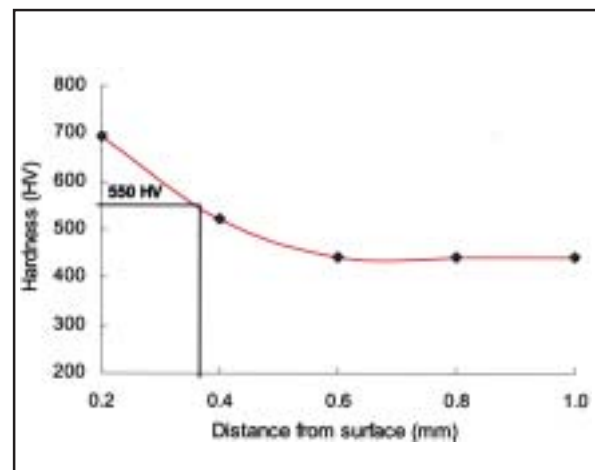
Figure 25. Hardness distribution across spur gear spline thickness.
