Fatigue Fracture of Bevel Gear of an Aeroengine Gearbox

Technical Report No: MT-FA-1000-05-2006

Subject :	Analysis of failed bevel gear and pinion of engine gearbox PT-6
Submission Date:	May 02, 2006
Issue Date:	May 29, 2006
Customer:	Not disclosed
Reference(s) :	Not disclosed
Total No. of pages:	Twelve (12)
Investigating Team:	M. Suresh Kumar, M. Madan, M.A. Venkataswamy, M. Sujata and S.K. Bhaumik
Approved By:	S.K. Bhaumik
Keywords:	Engine gearbox; bevel gear assembly; weld; residual stresses; fatigue

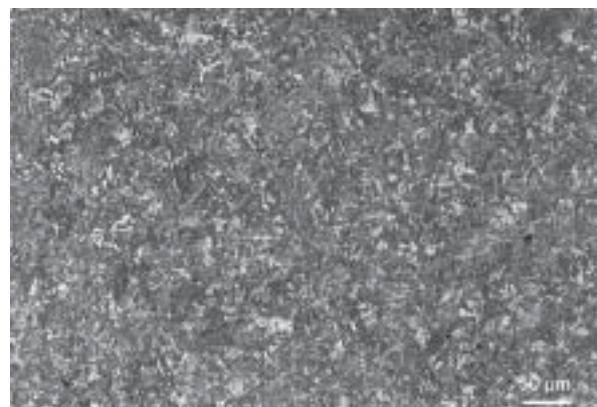
Figure 17. Optical microstructure of bevel gear material consisting of tempered martensitic structure; etched in 2% Nital solution.

The microstructure across the weld was examined in detail. The microstructure of bevel gear and spur gear material was found to be identical and it consisted of tempered martensitic structure (Fig.17 and 18). On the contrary, an untempered martensitic structure was observed in the weld (Fig.19). The weld structure was very coarse compared to that of the parent material of the gear. The microstructural variation across the weld was found to be significant. The teeth/splines of

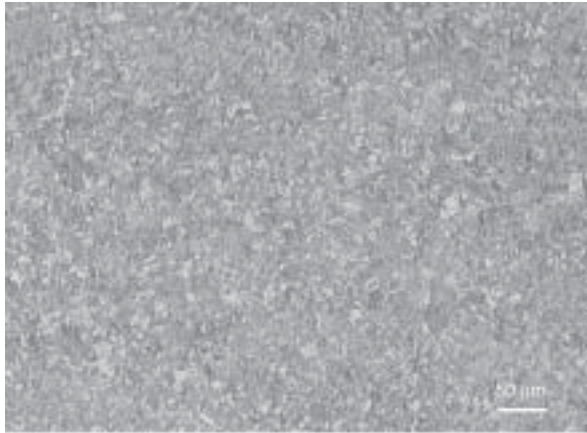
Figure 18. Optical microstructure of spur gear material consisting of tempered martensitic structure; etched in 2% Nital solution.

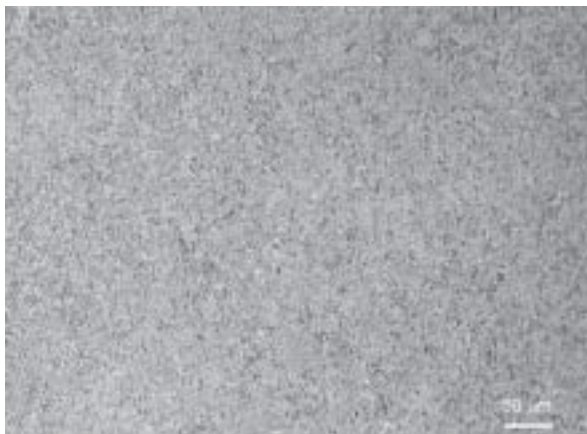
the gears showed satisfactory carburised/ carbonitrided structure (Fig.20).

Figure 20. Optical microstructure of the bevel gear teeth case, showing typical carburised structure; etched in 2% Nital solution.

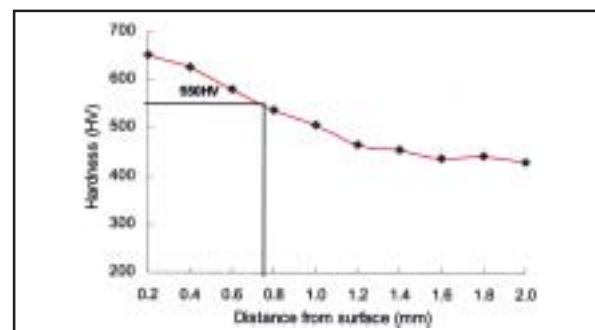
Figure 23. Hardness distribution across the bevel gear tooth thickness.

Hardness survey was carried out on metallographically prepared samples using a microhardness tester at a load of 500 g. The hardness profiles on the gear teeth/splines and across the weld are shown in Fig. 23 to 26. The results obtained are summarized in Table 2.

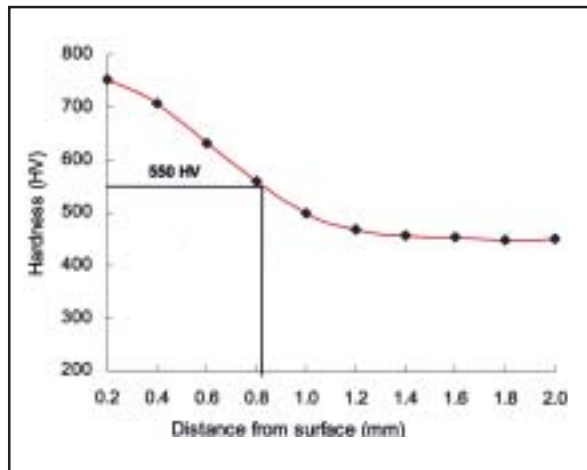
Figure 24. Hardness distribution across the spur gear tooth thickness.

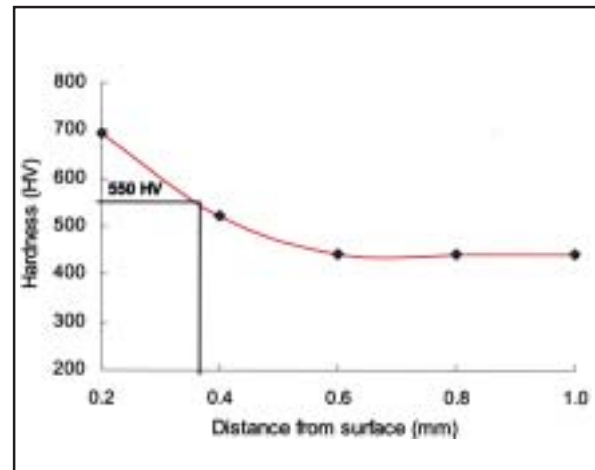
Figure 25. Hardness distribution across spur gear spline thickness.
