CSIR-NML's EXPERTISE ON LIFE ESTIMATION AND DAMAGE EVALUATION OF AIRCRAFTS

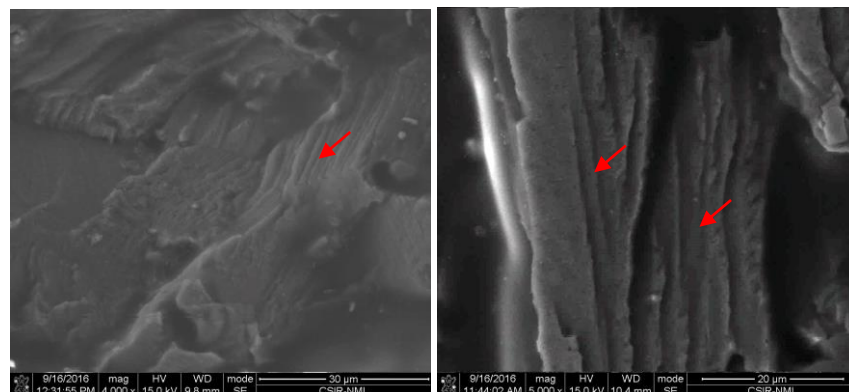
<p>Red dotted circle shows broken region</p>
Scope	<ol style="list-style-type: none"> 1) Visual examination, photographic recording and sampling of the damaged portion of the fairing assembly. 2) Chemical analysis. 3) Microstructural analysis and hardness measurement. 4) Fractography & surface analysis by SEM-EDS. 5) Identification of foreign object if any.
Finding	<p>Failure investigation of the broken fairing of aileron PCU-LH of Hawk MK132 A-3653 aircraft was carried out through visual examination, chemical analysis, microstructure analysis and fractography by SEM-EDS. Visual observation showed that the fairing was broken into two halves approximately at 20 mm from the tip. The broken piece was around 20mm X 35mm X 1.4mm in size. Visual examination and SEM-EDS analysis revealed several line marks near the fractured region due to cracking of the coating on the outer surface of the broken fairing tip. The cracks on the coating occurred due to the deformation of the base metal underneath the coating. Deformation of the base metal occurred because of stress concentration around the region. However, evidence of FOD was not found on the outer surface of the broken tip and rest part of the fairing. Visual examination of the inner surface of the broken fairing tip showed damage/removal of the coating at the tip region. Beside damage of the coating at the tip, no other damage was observed in rest portion of the fairing. SEM-EDS analysis of the damaged coating showed that the inner coating was removed by the repeated knocking of</p>

the tip against the surface of the wing. Chemical analysis of the fairing material showed that it was made of Al-Cu alloy of 2014 grade. Microstructure analysis and hardness measurement also conformed to the aluminium alloy of grade 2014. Fractography of the fractured surface revealed the signatures of progressive mode of failure. Hence it was concluded that the fairing was broken due to fatigue failure and not due to shearing/overload failure. Hence failure due to impact of an object was ruled out. SEM-EDS analysis showed that fatigue crack initiation and propagation was from the inner surface of the fairing. Fatigue failure occurred because of repeated knocking of the tip against the wing. Repeated knocking action might have been due to the existence of slight relative movement and aerodynamic condition prevailing on the fairing during service operation.

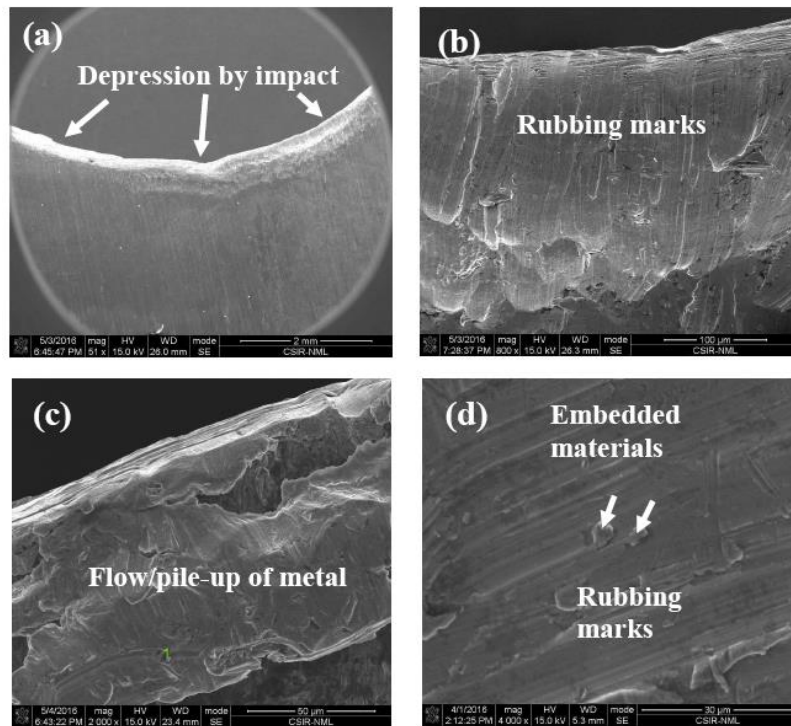
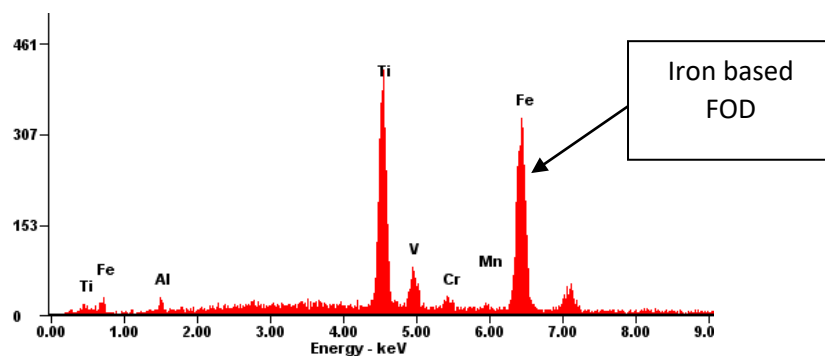
<p>(a)</p>
Scope	<ol style="list-style-type: none"> 1) Visual examination, photographic recording and sampling of the damaged portion of the blades. 2) Chemical analysis 3) Microstructural analysis and Hardness measurement. 4) Fractography & elemental analysis by SEM-EDS. 5) Identification of foreign object if any based on the above investigation.
Finding	<p>Failure/defect analysis of two damaged blades (Blade No.15 and Blade No.33) of aero engine of SU-30MKI was carried out through visual examination, chemical analysis, microstructure analysis and fractography by SEM-EDS to find the cause of damage. Visual examination showed that both the blades were damaged in the form of dent/notch along the leading edges possibly due to impacts by hard objects. Blade No.15 was damaged at a single location and was located at 27 mm from the tip of the blade on the leading edge. The dent/notch of blade No.15 was approximately 15 mm wide and 3 mm deep. Blade No.33 was damaged at three locations which were marked as Dent 1, Dent 2 and Dent 3 for convenience as shown in Figure. Dent1 was located at 6 mm, Dent 2 was located at 31 mm and Dent 3 was located</p>

at 84.5 mm from the tip of the blade along the leading edge. Dent 1 was approximately 4 mm wide and 5.5 mm deep, Dent 2 was approximately 20.5 mm wide and 3.5 mm deep and Dent 3 was approximately 8.5 mm wide and 1 mm deep. Chemical analysis confirmed that the blades were made of titanium based alloy of type (Ti-6Al-4V). Microstructure analysis did not show any abnormality in the microstructure of the blades. Microstructure of the blades was consisting of alpha (α) and alpha + beta ($\alpha+\beta$) structure of Ti-6Al-4V alloy. Fractography/damaged surface analysis by SEM-EDS confirmed that blades were damaged due to impacts of an iron based metallic object.

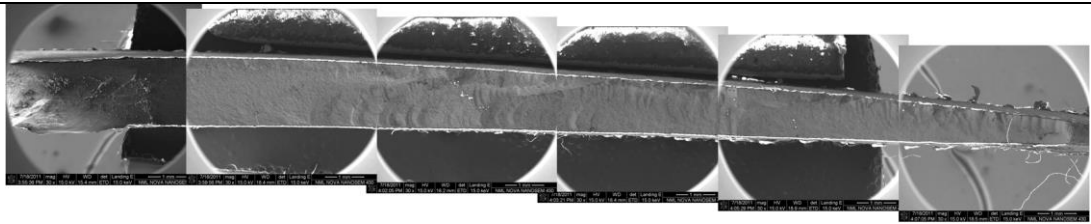
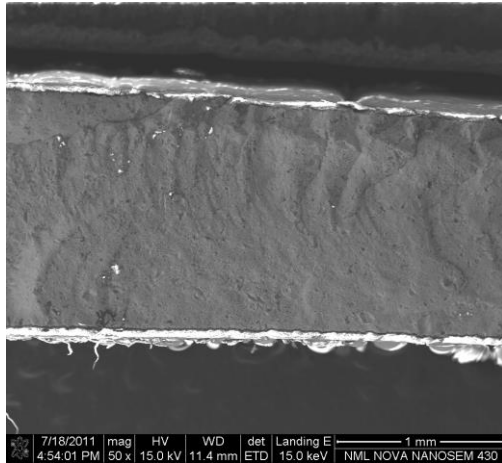
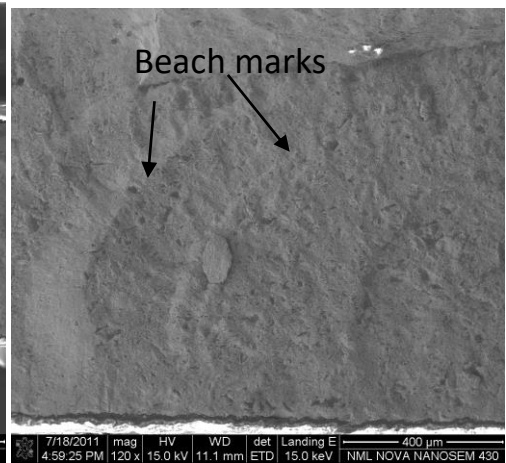
Scope	<ol style="list-style-type: none"> 1. Visual examination and photographs recording 2. SEM Fractographic study to find out the failure mode/mechanism. 3. Surface studies to find out nature and mechanism of surface degradation/damages. 4. Microstructure investigation and EDS microanalysis. 5. Hardness measurement.
Finding	<p>Failure investigation of a damaged second stage compressor rotor blade of R-13 aero engine was carried out. No microstructural/material defect was observed. The blade is made of martensitic stainless steel of Russian grade AE 961W and has protective coating. The hardness value of the blade is within specified limit. The pressure surface of the blade has undergone erosion in the form of cracks, pits/craters by impact of sand particles. Protective coating was completely eroded along the leading edge near tip region due to abrasion of sand particles. The failure of the blade was due to fatigue initiated from the pits/craters formed on the bare base metal due to impact of sand particles. Fatigue crack was propagated from surface crack/crater due to complex cyclic loading condition of engine off and on; coupled with vibration characteristics during flight.</p> <p>In order to mitigate the problem, frequent inspection of blades for coating damages should be carried out. Secondly, feasibility of recoating of blades along leading edges as coating gets damaged may be explored.</p>

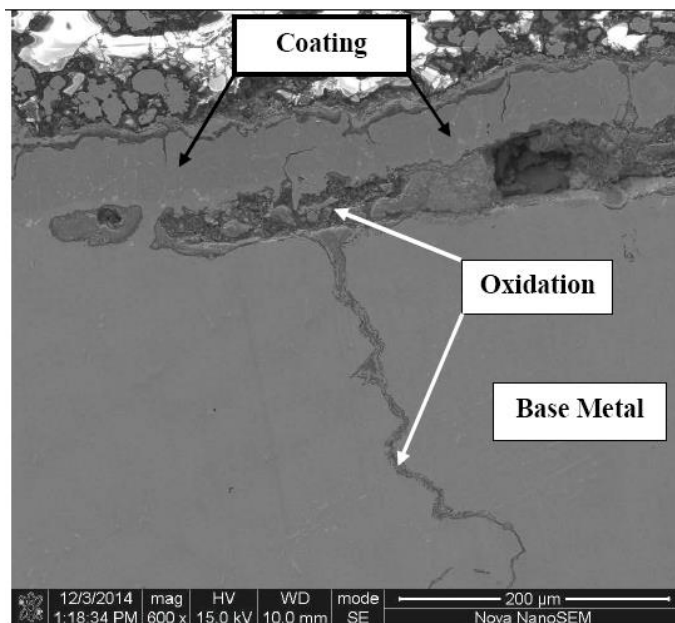
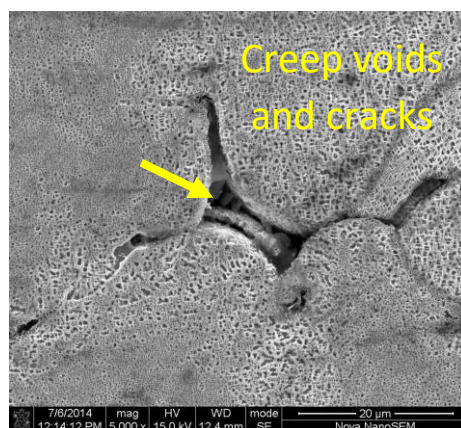
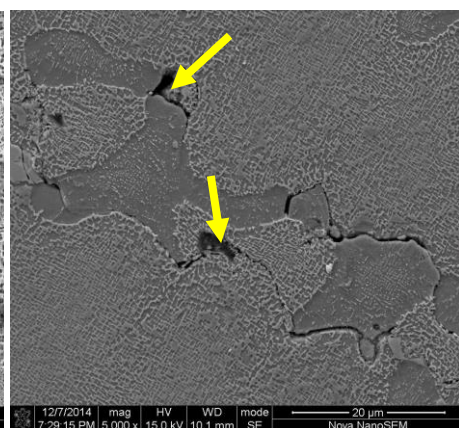
Scope	<ul style="list-style-type: none"> ➤ Visual examination and photographs recording. ➤ Chemical analysis. ➤ SEM Fractographic study to find out the failure mode/mechanism. ➤ Microstructure investigation/analysis and Hardness measurement. ➤ Microstructure analysis and Coating analysis of the undamaged NGV by Optical Microscopy and Scanning Electron Microscopy (SEM).
Finding	<p>Failure investigation of a damaged 1st stage nozzle guide vane (NGV) of R-25 aero engine was carried out to determine cause of failure, coating condition and material degradation due to high temperature in comparison to an undamaged nozzle guide vane obtained from the same stage. Chemical analysis of both NGV's conforms to nickel based super alloy of Russian grade ZC6Y-BE. Microstructure analysis showed that both NGV's consist of gamma and gamma prime (γ-γ') matrix having cast dendritic morphology along with coarser primary carbides. Discontinuities/cavities at inter-dendritic region were also observed in both the NGV's. However the microstructural degradation is more predominant at the damaged location of the damaged NGV's. It is interesting to note that at the same location for the undamaged NGV also showed similar microstructural degradation.</p> <p>Coating analysis revealed degradation / depletion of coating at the</p>

leading edge of the undamaged NGV. However at the trailing edge (suction side) the coating thickness was heavy appears to be second coating. In case of failed NGV, the coating was damaged/depleted up to ~5 mm from the damaged portion towards the shrouded end.

Failure of the 1st stage nozzle guide vane (NGV) was due to high temperature oxidation assisted by creep and thermal fatigue. Degradation /damage of coating might have assisted the high temperature oxidation to occur. Rise in temperature accelerated the precipitation and coarsening of chromium rich secondary carbides rendering the oxidation of Ni base matrix especially around chromium rich precipitates. Inter dendritic cavities/discontinuities were generated because of high temperature creep and thermal fatigue. These cavities/discontinuities provided the easy diffusion paths for oxygen transport enhancing high temperature oxidation of the nickel matrix.

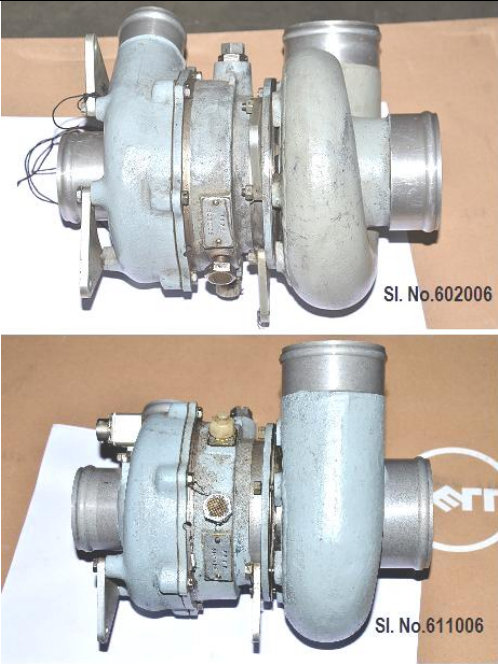
Scope	<ol style="list-style-type: none"> 1. Visual inspection and photography; 2. Chemical analysis; 3. Microstructural analysis; 4. Fractography & SEM-EDS analysis; 5. Identification of probable foreign objects and dislodged metallic particle 	
Finding	<p>Metallurgical analysis of turbo coolers 7171 (Sl. No. 602006 & Sl. No. 611006) of MIG-21 Bison: CU-2069 was carried out by visual examination, fractography, chemical analysis and SEM-EDS analysis. Macro and microscopic examination revealed severe damages in turbo cooler having Sl. No. 602006. The shaft was broken into two pieces and fan blades, fan casing and guide wheel of the turbo cooler were damaged/worn-out. However, only fan blades and casing of the turbo cooler Sl. No. 611006 are found in damaged condition. Severe impingement/impacts marks were found on the casing of the fans of both the turbo coolers. Experimental results confirm that the turbo cooler were failed by erosion and damage due to the impingements/impacts of multiple objects on the fan blades of the turbo coolers. The embedded-foreign-objects-rock/sand consisting of Si, Al, O, Ca, K Mg, Na etc. were detected by SEM-EDS along with carbon sulphur, iron, tin and copper based metallic materials. As received six FODs were identified as magnetic and non-magnetic metallic objects. However, the damages to the rotor shaft, guide wheel and other components of turbo cooler Sl. No. 602006 are secondary in nature.</p>

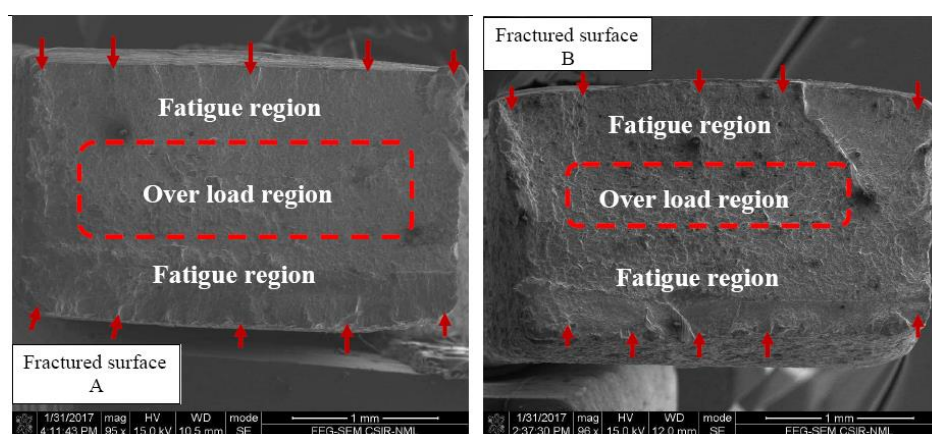
Scope	<ul style="list-style-type: none"> ➤ Visual examination and photographic recording. ➤ Chemical analysis ➤ SEM fractography and surface study to find out the failure mode/mechanism. ➤ Metallographic study and hardness measurements to find out any unusual microstructural features, if any. ➤ To find out the causes and circumstances of failure and suggest remedial measures
Finding	<p>Failure investigation of the broken mounting bracket (Pt. No-75-5102-92) of DASU-1A of Mig-21 (Bison) aircraft CU-2316 was carried out through visual examination, chemical analysis, microstructure analysis and fractography by SEM-EDS. The mounting bracket was broken into two pieces from the centre hole. It was ruptured along the transverse section at two locations along the diagonal of the centre hole creating four fractured surfaces (i.e. two mating fracture surfaces from one location). Fractured surface from one location is marked A and the other fractured surface from the diagonally opposite location is marked B for convenience. During visual examination, significant corrosion/oxide</p>

formation observed on the fractured surface B, compared to the fractured surface A. Significant corrosion/oxide formation on the fracture surface may be inferred that it is a time dependent failure and not a sudden failure. Microstructure consists of tempered martensite with slightly higher amount of inclusions. Tempered martensite is common in quenched and tempered low alloy steel. Fractographic studies by SEM-EDS revealed regular steps marks due to crack propagation by cyclic load and elongated radial cracks around the neutral axis (central region) due to the detachment of interfaces between the matrix and inclusions, hence it may be inferred that that the bracket was failed due to reverse bending fatigue. Fatigue was initiated from the inclusions situated on surfaces/subsurface of the bracket under the reverse bending load and propagated for some time before fracture. Moreover, corrosion product/oxides on the fatigue cracked surface were also noticed indicating time dependent fatigue failure. The reverse bending fatigue condition might have arisen due to improper fastening /loose of the mounting bracket coupled with vibration of the aircraft. Moreover, martensitic steels are low fracture toughness materials and aggravated by the presence of inclusions, hence could not with stand the fatigue load.
