CSIR INDUSTRY MEET

Theme- Technologies for Aerospace, Electronics,
Instrumentation & Strategic Sectors

TECHNOLOGIES DEVELOPED

CSIR-NATIONAL METALLURGICAL LABORATORY,

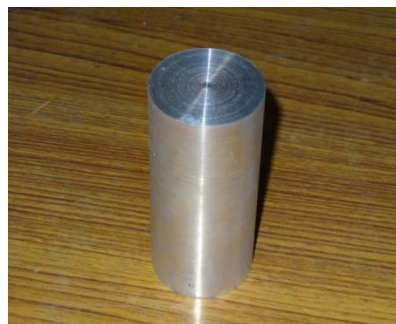
Al-Alloy Ingot

- Al & Al alloy coatings by sputtering (Target to coating and its evaluation)

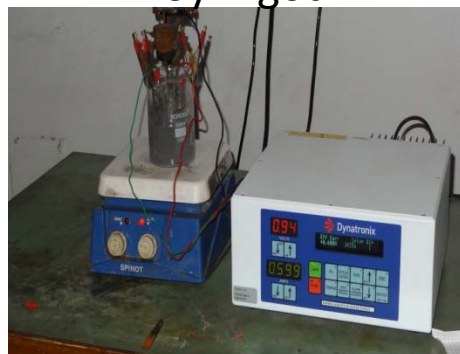
Electrochemical set up

- Al coatings by electrodeposition route using ionic liquid

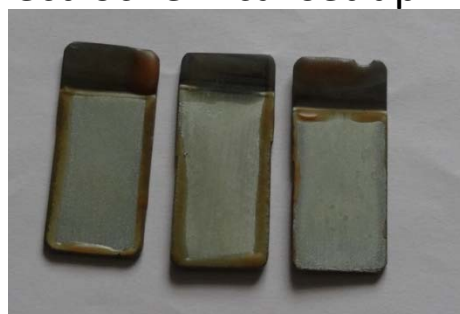
CMMA Zn-Fe Coatings

- Compositionally modulated multi-layered Alloy (CMMA) coatings

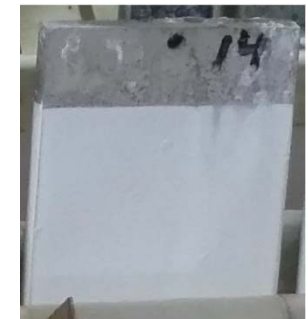
1000 hours

- CSIR-NML has developed Cr free conversion coating for Al-Alloy
- The process is fast and low temperature curable (less than 30 min, less than 80 C)
- Meets the requirements in MIL-DTL-81706 (336 hours of salt spray test and cross hatch adhesion test)

Salt Spray Test

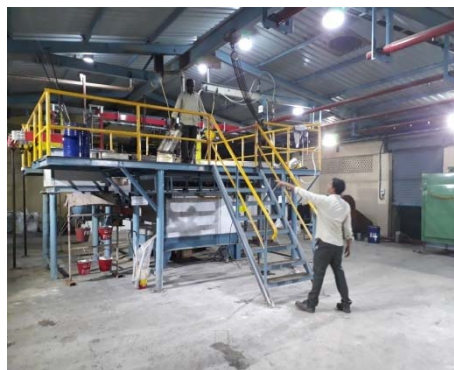
Sodium Pilot Plant

❑ **Pilot Scale:** 3000A close cell operation at M/s SRHHL, Kurnool

- Scale- up design, fabrication of 3000A cell based on NML's 500A cell
- Commissioning of 3000A cell at Kurnool
- Purity of sodium metal 98.7 - 99.8%
- Current efficiency 75 – 80%

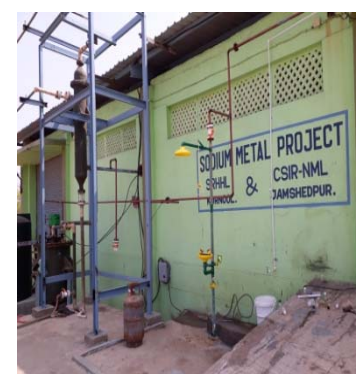
Production of sodium
hypo chloride with
chlorine gas

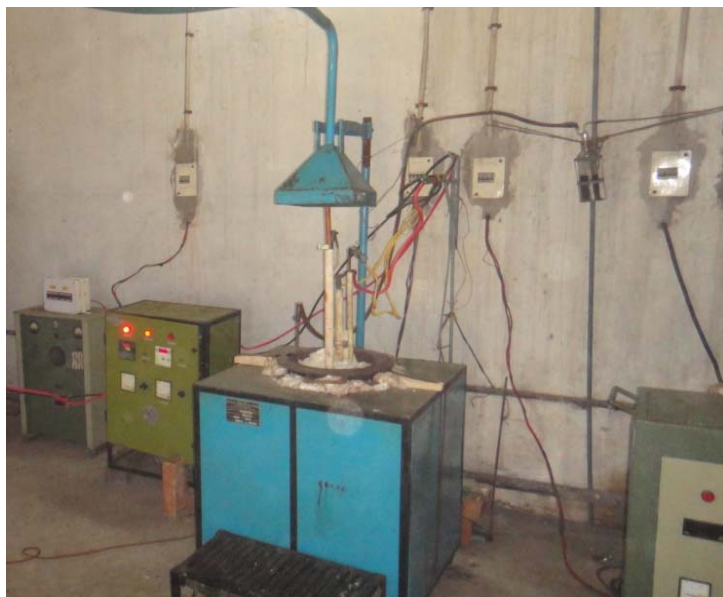
Electrolyser 100A Capacity

- Design of close cell,
- operated at $800 - 700^\circ\text{C}$ for 6-8 hrs,
- Bath: Mixed chlorides
- Feed : GdCl_3
- Current: 100A, 5-7V
- Efficiency: 40 – 50%

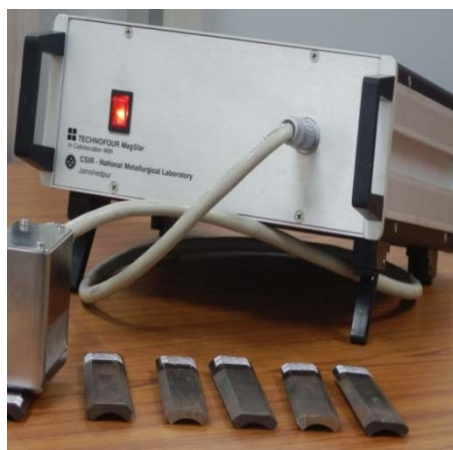
Phase evaluation of ferritic steels

MagStar is a portable electromagnetic sensing device for Non-destructive evaluation of steel structure/components. Sensor probe head is used for magnetic excitation and flux pick up from the test object to generate Magnetic Hysteresis Loop (MHL) and Magnetic Barkhausen Emission (MBE) signals.

- Microstructural phase evaluation of ferritic steels
- Sorting of service exposed CRGO sheets
- Creep damage assessment of boiler tubes / pipes
- Evaluation of residual stress in aircraft landing gear steels (HSLA).

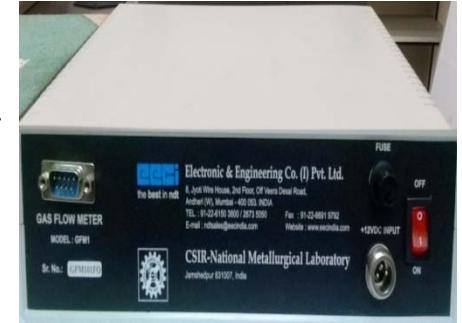
- On-board End of Life estimation of Spacecraft
- Fuel estimation of aero engines
- As a Gas flow meter
